Inspection Report
Minerals Regulatory Program

Mine Name: Quartz Hill
Operator Name: Kerry Holt Hay Cubes, Inc.
Kerry Holt
P.O. Box 249
Enterprise, Utah 84725

Permit number: S/021/036
Date: September 14, 2006
Time: 5:00 PM

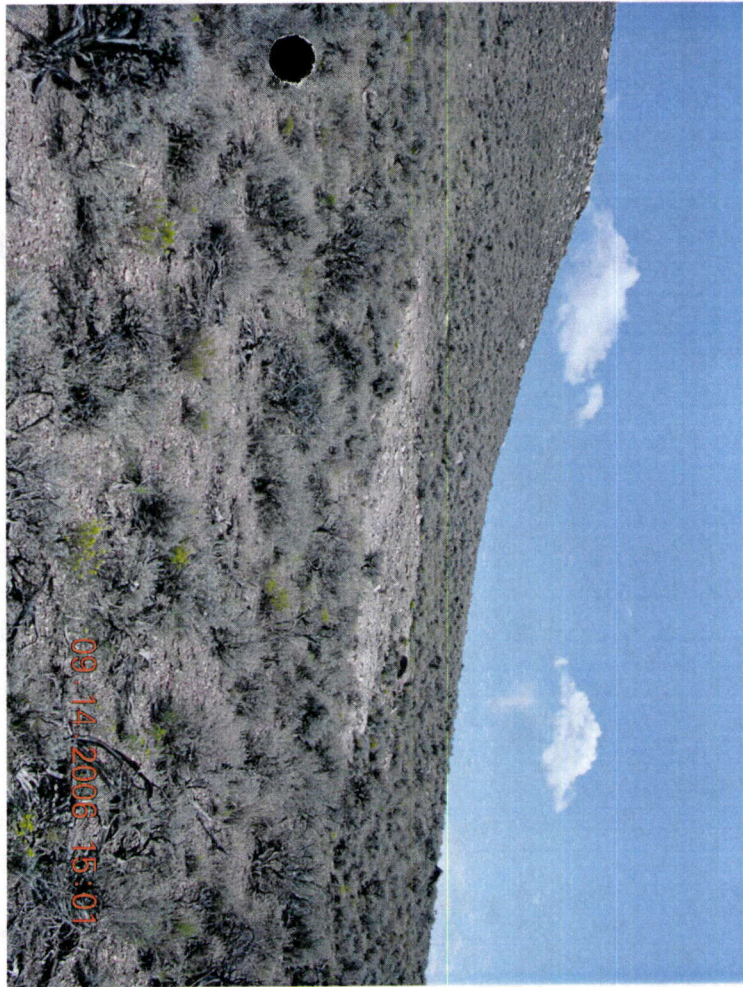
Pt 1

The operator had only dug two small trenches at the site to check for the existence of sufficient rock. The result of the trenching was that there was too much overburden in the area to make mining profitable. Pictures were taken of the site and are included in this report.

The operator has backfilled the trenches and is no longer interested in pursuing any further mining activity in the area.
